DIY for repair the FT 817D in fault

by Francia Giovanni I0KQB

(Extract from E.R.A. Magazine September 2014)

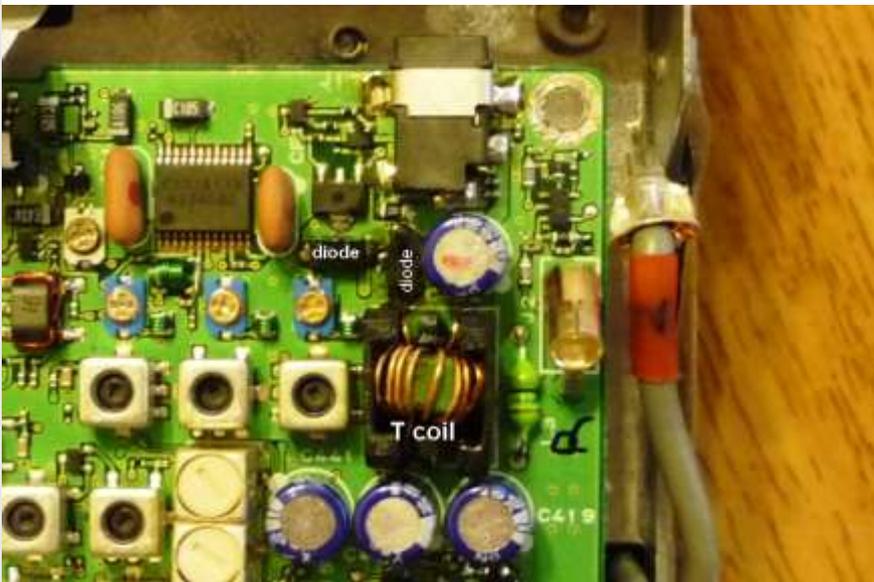
Photo 1

1. On the main board get a look to the D 1084 and D 1085 (these are Schottky diodes RSX 30-1L-30). They'd probably be exploded! Look at the photo 1.
2. On the main board as well, there is the T 1035 (a little toroid with a double two coils of copper) that I desoldered , cleaned with pure alcohol and then remade using new copper wire . That's very simple to remade by hand.
3. If you have been unlucky , probably you'll need to bypass the F 1001 –a fuse 3.15 A (it permits to the rtx to recharge the battery pack)- it's collocated exactly beneath on the left of the switcher Headphones-Speaker and the C 370 , of course always from the mainboard's point of view. Sorry to say that it's an ultra micro component that's very difficult to replace. I bypassed it and everything is working properly.

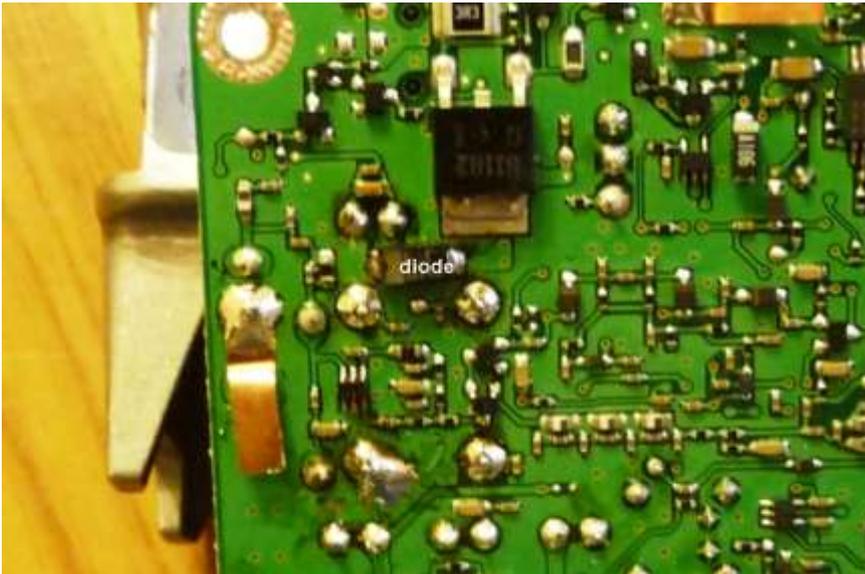
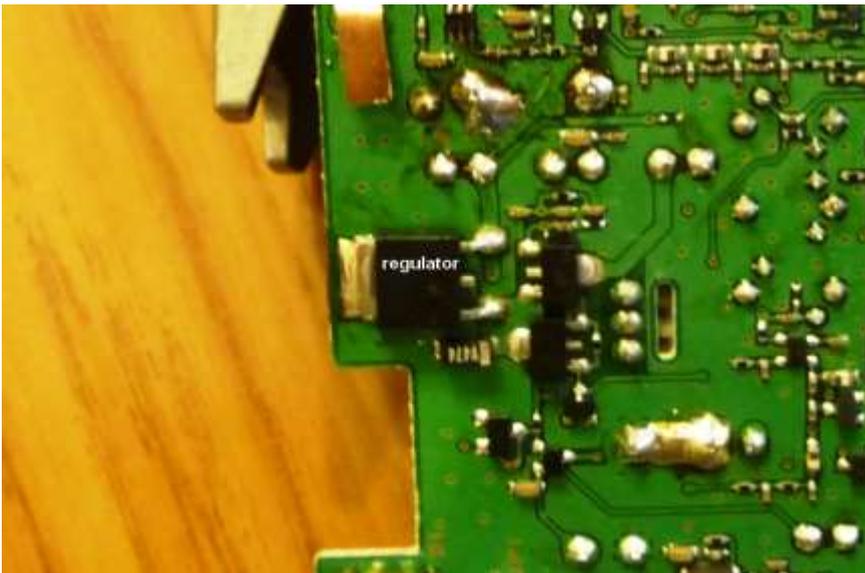
Photo 2

4. Get a look(Photo 2 and 3) and test the D 1084 (it's a RSX 30-1L-30 diode as well). Probably it'll be fault. Change it .
5. Test the Q 1108 8 5 volts regulator) and if it needs, change it.
6. That's all for the first trouble. If you were lucky, that was all you needed to change.

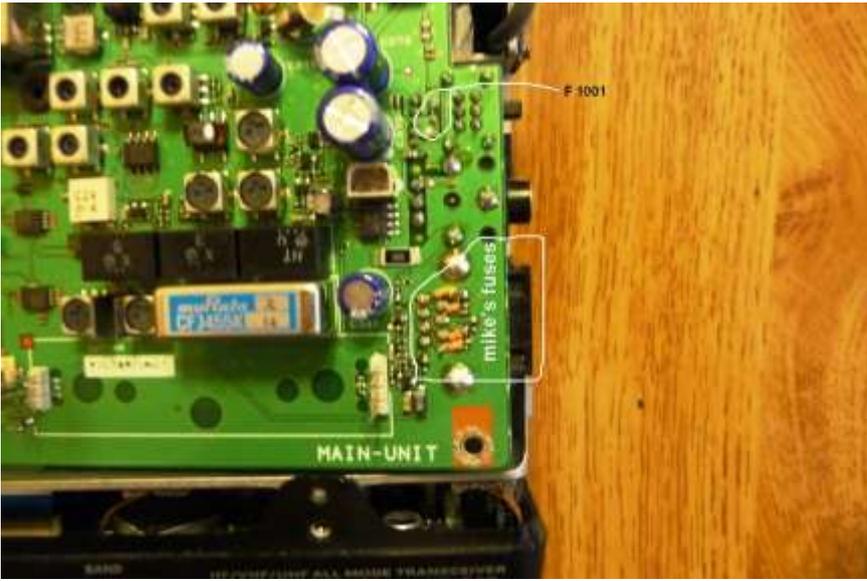
Photo 4

Now, let's to speak about the second troubleshoot, I mean the microphone's fuses. Look at the photo 4.

If they are broken, you won't be allowed to switch from RX to TX. Not bad, is it? These are collocated on the main board, exactly where the RJ 45 mike's socket is collocated

Be patience and with the help of your multimeter, test the R 1415, 1416, 1417, 1418. As you can see in my photos and as you'll see by yourself observing your rtx, they are damned little, very little. I bypassed them, using a wire as thin as a single hair, protecting them with very little plastic tubes.
